## Stent edge malapposition causing restenosis and ACS

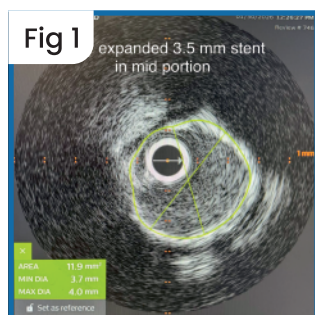
A 69 y old female had undergone angioplasty and stenting to LAD in February 2021 for unstable angina at another hospital. A 3.0 mm x 15 mm DES was deployed in proximal LAD and was post dilated by a 3.5 mm non compliant balloon. In January 2026 she presented with anterior wall STEMI and was immediately thrombolysed. She was compliant with statin and dual antiplatelet therapy (Clopidogrel and Aspirin). Coronary angiogram revealed presence of a 70–80% stenosis in proximal LAD just after the ostium abutting on the proximal edge of the stent (Video 1). IVUS evaluation revealed presence of a well deployed stent in proximal LAD (Fig 1) however the proximal edge of the stent was clearly malapposed with a wide gap between the stent and the vessel wall (Fig 2, black arrows). The MLD at the edge was 2.6 mm (Fig 3). There was a good landing zone at the LAD ostium (Fig 4). The malapposed stent proximal edge probably acted as a nidus for development of plaque which ruptured this time to cause STEMI. The lesion was first dilated with a 3.0 mm NC balloon and was then treated with another overlapping 3.5 mm x 12 mm DES with excellent angiographic result. (Note: A 2.5 mm x 12 mm balloon was placed in the circumflex at the time of stent deployment to prevent carina shift) (Videos 2 & 3).

1. Deliberate avoidance on the part of the operator to post-dilate the edge due to fear of dissecting the adjacent normal vessel.
2. Using balloons with longer shoulder (and balloon overhang) which fail to post-dilate the distal part and the stent edge (Fig 5A). It is important to make sure that the stent edges lie in the true cylindrical zone of the balloon (which is inside its shoulders) which is the true dilating part of the balloon. The shoulders do not exert much radial force on the stent. Most of the newer generation balloons have a very short shoulder and the overhanging portion. This makes the geographic miss of the stent edge less likely (Fig 5B).
3. A wedge of calcium under the edge of the stent

Mechanisms 1 and/or 2 could have played a role in this case. The vessel around the malapposed stent edge appeared normal making mechanism 3 unlikely.

Under-expansion of the stent edge causing malapposition can cause in-stent restenosis (ISR) and ACS. This usually occurs due to deliberate non-dilation of stent edge due to fear of dissection of adjacent normal vessel or use of post-dilatation balloons with long shoulder.
